Fatality Investigation Report

OR 2012-18-1

Experienced Journeyman Machinist Killed While Operating an Engine Lathe

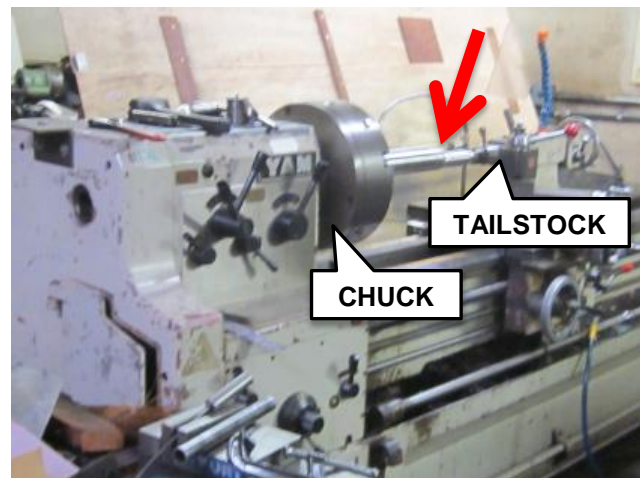
The engine lathe where the event occurred. The arrow indicates where the victim became entangled.

- The OR-OSHA investigator believed that the victim's loose fitting cut-off sweatshirt was the first point of entanglement with the work piece. The most common causes of death and injury from metal lathes include entanglement of clothing in moving parts, being hit by loose objects on the lathe (e.g., chuck keys, tools, metal shavings) and being struck by a part that has not been adequately secured (see reference Work Safe Victoria, September 2010). To prevent entanglement, recognized accepted practices include prohibiting loose clothing, jewelry, gloves and unsecured long hair around rotating equipment.

Recommendation #1: Employers should establish, communicate and enforce a clothing policy specific to the work environment and particularly for machine operators.

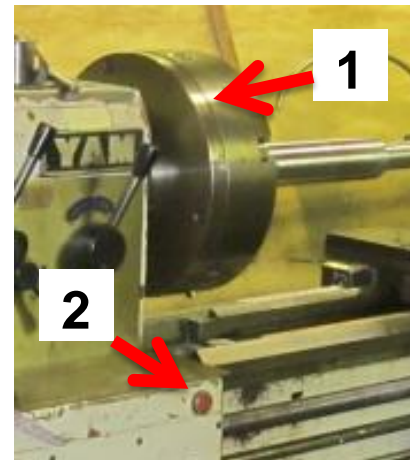
ABOVE: (1) Lathe involved in the incident with unguarded chuck and (2) red “inch” (or jog) button.

- Job hazard analysis is especially critical when there are legacy machines with varying hazard controls. These job hazard analyses should be used to create SOPs that would eliminate and/or control the hazards. The investigation revealed that there were several engine lathes in the shop. The engineering or regulatory standards at the time of manufacture or country where manufactured were likely different. For example, the machine involved in the incident had a red button that was not an emergency stop whereas another engine lathe had two red emergency stops. Current OSHA regulations or ANSI Z535.1-1998 do not specify which machine parts require color-coding. However, a standard interpretation (see reference OSHA, Standards Interpretation) states, that the “employer has the responsibility to evaluate the machine and determine if any portion needs to be color-coded.” In this particular case employees assumed that the red button on the engine lathe was an emergency stop. Training, labeling, or changing the color of the button after a job hazard analysis would have corrected the mistaken assumption that the “inch” button was an emergency stop. After the incident the employer painted the brake bar red, covered the “inch button” and had begun the process to add an emergency stop on the lathe involved in the incident.

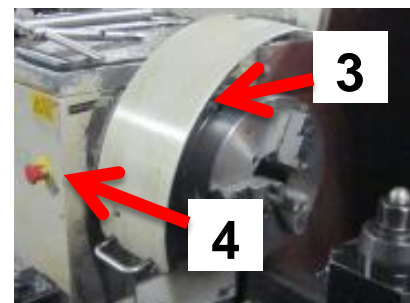
BELOW: (3) Lathe manufactured in England also on site with interlocking chuck guard and (4) red “emergency stop.”

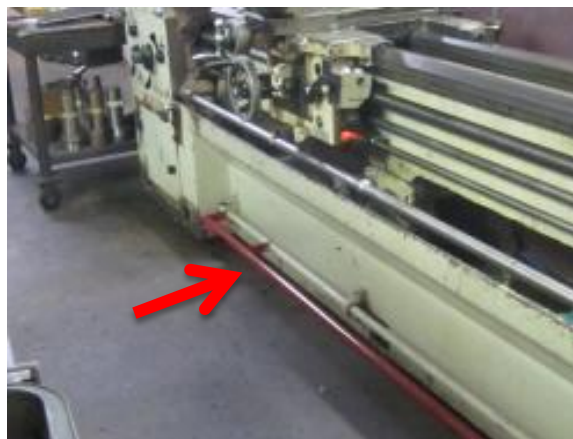
While doing so his own arm was repeatedly struck by the eccentric shaft until his cry for help summoned the manager who upon arriving at the scene immediately stepped on the brake bar, stopping the machine.

Brake bar on the engine lathe, which was painted red following the incident

Recommendation #5: Employers should implement preventive maintenance and inspection processes for hazardous machines. Where necessary, employers should install, adjust, label and/or repair appropriate controls (e.g., machine guards, emergency stops).

- During routine preventive maintenance it might have been discovered that the red button was not an emergency stop. Preventive maintenance can also ensure controls for recognized hazards are installed consistently across similar equipment. Manufacturers of equipment and aftermarket safety equipment should be consulted for the type of controls.
