Fatality Investigation Report

OR 2005-43-1

Mill worker killed by flying chunk of wood from chipper

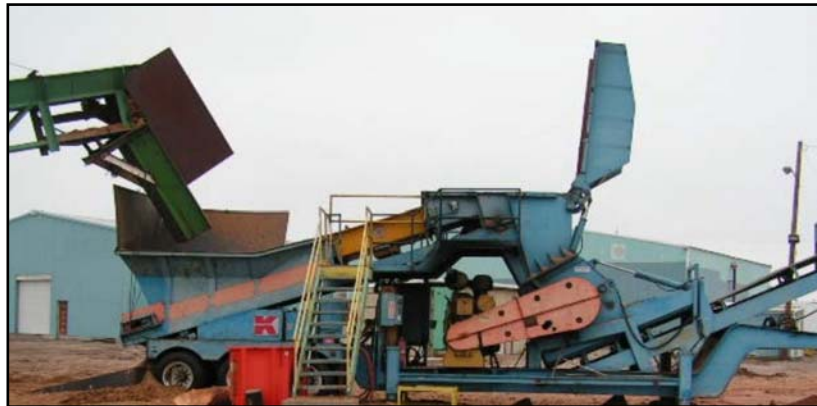
An electric switch was installed on the wood chipper in this incident to allow the hood to open without shutting down the machine, bypassing the manufacturer's safety shutdown mechanism.

Recommendation #2. Never disable the manufacturer's safety interlocks or other safety features on a machine.

This incident emphasizes the danger of disabling a manufacturer's safety features on a machine. Clearing a jam on a wood chipper with the machine running may save time, but employers must not compromise worker safety by installing bypass switches, or training or allowing workers to violate safe operating procedures. In this case, the manufacturer's safety interlock mechanism on the hood of the wood chipper followed legal requirements to protect workers from flying objects. A wood chipper and similar grinding machines must be shut down completely before opening the hood to the infeed chute.

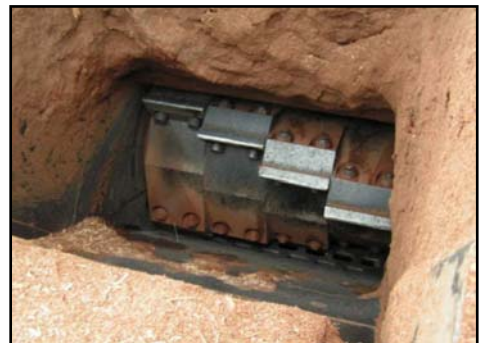
Looking down the throat of the hog inside the infeed chute of the wood chipper shows the hammers that pulverize wood into boiler fuel.

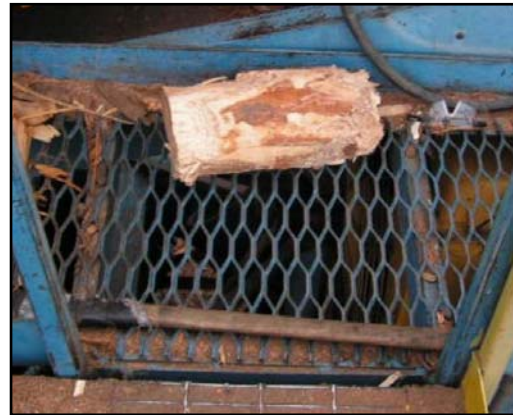
The 18-inch chunk of wood that struck the victim was only slightly shaved by the hog before it was forcefully ejected beyond the open hood of the bin.

Recommendation #1. Never attempt to remove jammed material from a wood chipper while machinery is in operation. Shut down, isolate, and block all forms of hazardous energy before performing any machine maintenance.

This incident emphasizes the danger of attempting to clear a jam in a wood chipper without first shutting down the machine. All maintenance related to the point of operation of a machine, including clearing jammed material, should be performed only after shutting down the machine completely and blocking all forms of hazardous energy.
