**REPORT#:** 2022OR01

**REPORT DATE:** May 28th, 2023

## Wildland Firefighter struck and fatally injured by hazard tree—Oregon

### Fatality Assessment & Control Evaluation

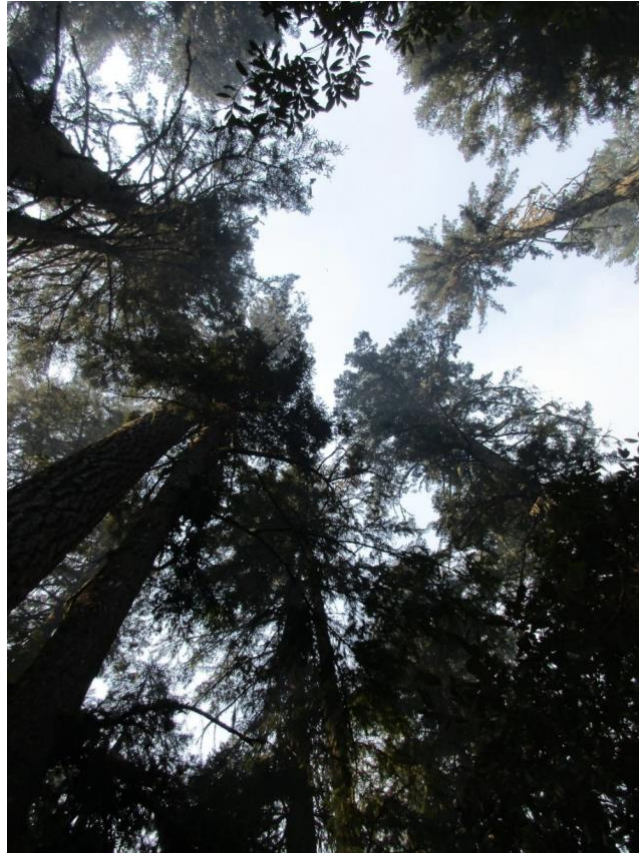
**Image 3. View from beneath the forest canopy at the incident site (Oregon Department of Forestry and Bureau of Land Management Serious Accident Investigation Report, 2023).**

in this location were approximately 150 feet tall. **Image 3** is a photo taken from the incident site looking up at the forest canopy.

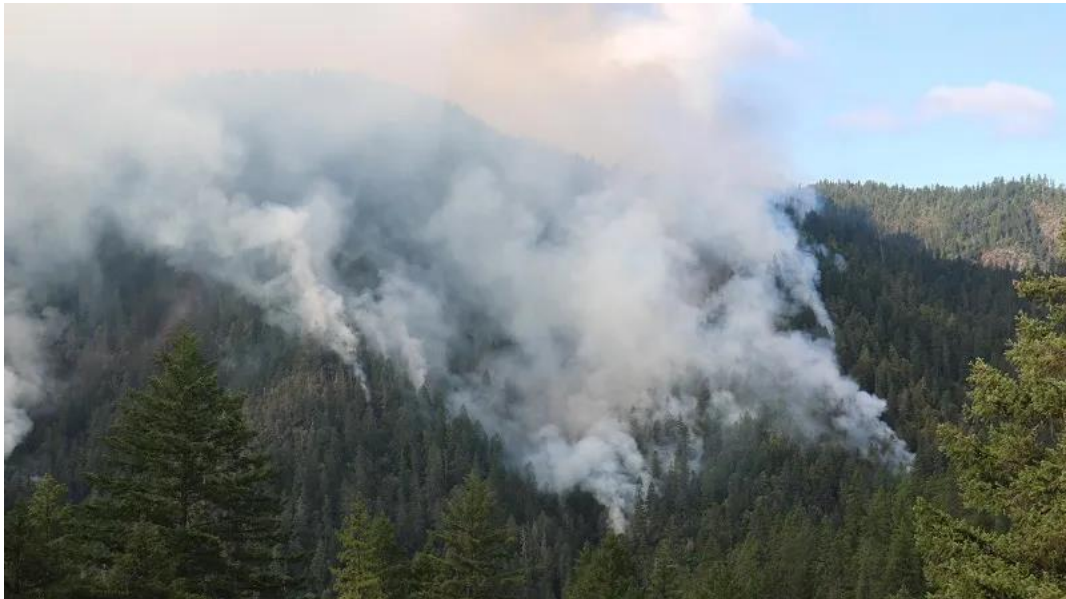
**Image 4. Image of the fire and terrain from local news taken on August 23rd, 2022 (KOIN 6, 2022).**

A photo of the wildfire and terrain is shown in **Image 4**. This photo was taken by a local news network on August 23rd, 2022, six days after the start of the fire but prior to it spreading significantly.

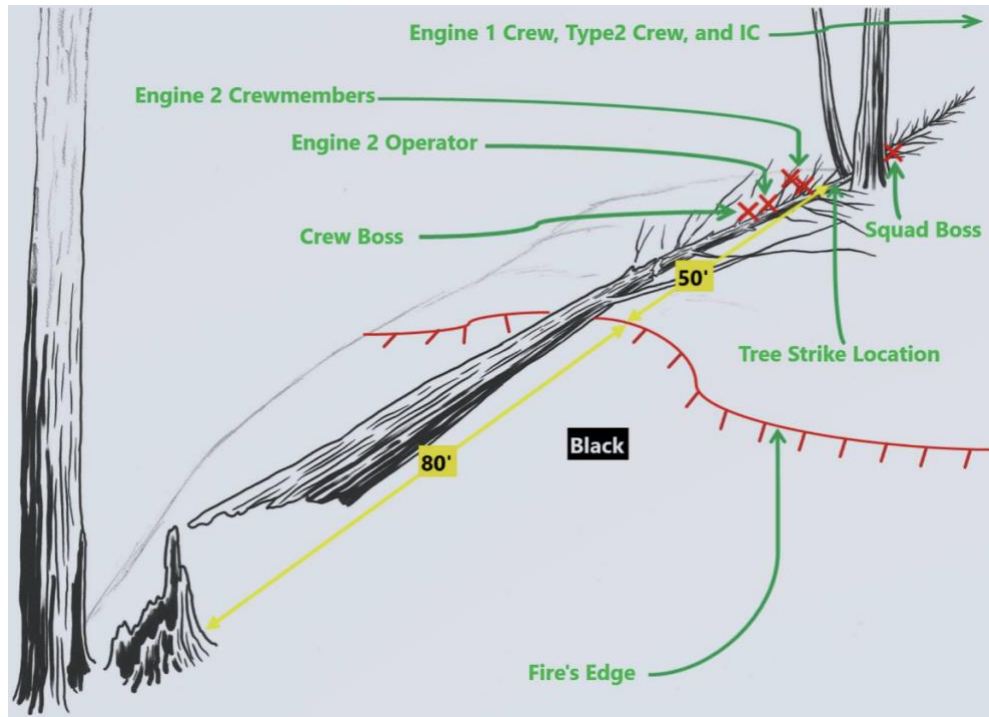
The hazard tree that struck the firefighter was a 160-foot-tall Douglas fir tree with a diameter of 39 inches. It fell from within the fire perimeter and had not been visible to the crew prior to falling due to the reduced visibility from undergrowth and smoke from the fire. The onsite investigation after the tree strike found that this tree had been previously burned, as noted by past scarring on the tree and surrounding trees. This tree also had a weakened base and internal deterioration from fungus. There was no work being done on or near the tree when it fell.

The diagram shown below in **Image 5** is a drawing of where the tree fell in relation to the crew members, the crew boss, and where the firefighter (identified as Engine 2 operator) was struck.

**Image 5. Diagram of the tree fall and location of crew members, the decedent's location is identified by "Engine 2 Operator," and his crewmembers are referred to as "Engine 2 Crewmembers," and "IC" is the incident commander. (Oregon Department of Forestry and Bureau of Land Management Serious Accident Investigation Report, 2023).**

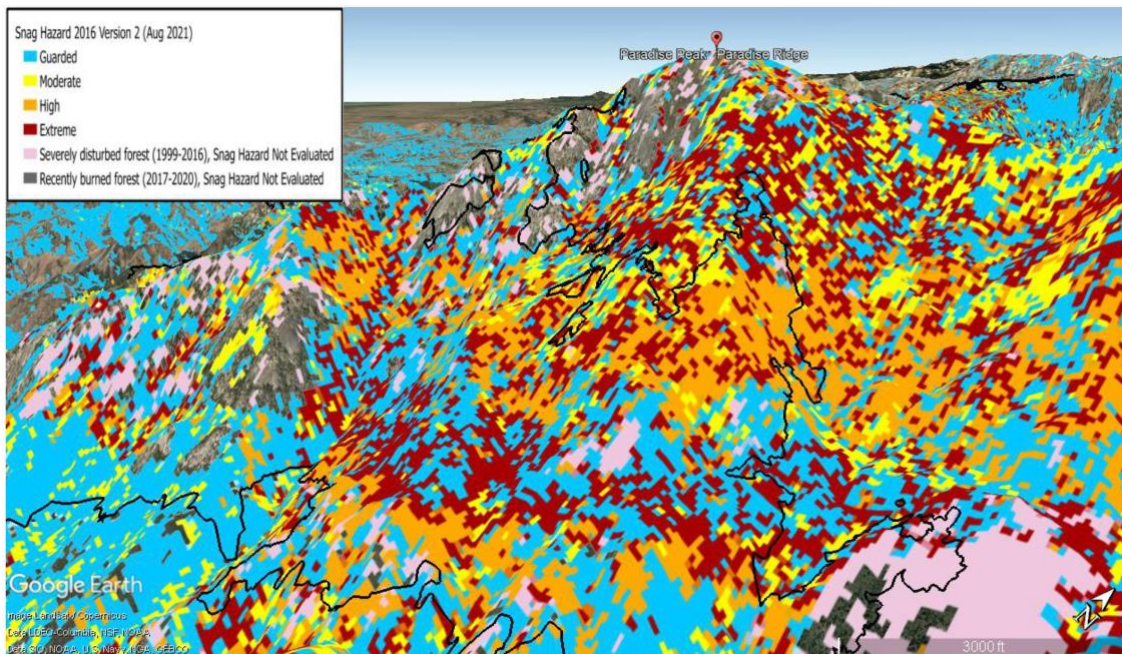
A study published in 2022 found that tree hazards are one of the top five causes of fatalities for wildland firefighters (Riley, et. al., 2022). Because of this, hazard trees should be prioritized as a potential risk to crew members during the fire size-up phase of the response. A resource that has been developed that can provide additional information when assessing risk and implementing precautions is the Snag Hazard Map, a component of the Risk Management Assistance (RMA) Dashboard. This resource assigns a hazard rating to forest locations across the United States to help responders make more informed risk assessments related to tree hazards. An example of this resource is shown in **Image 6**.

**Image 6.** Example of the Snag Hazard Map as a 3D representation (Riley, et.al., 2022).

Identification of hazard trees during the risk assessment can include hearing falling trees, noting previous burn scars in the area, or a moderate to high snag hazard level on the RMA dashboard. If there are any indications that tree hazards may be at an increased risk in the fire response area, strategies, including implementing lookouts and safe distance guidelines, should be utilized.
